## **Evaluation of FiberMat® Type B as a Stress Absorbing Membrane Interlayer to Minimize Reflective Cracking in Asphalt Pavements**

Arif Chowdhury, P.E.  
Assistant Research Engineer  
Texas Transportation Institute

Texas Transportation Institute  
Texas A&M University  
College Station, Texas  
September 2007

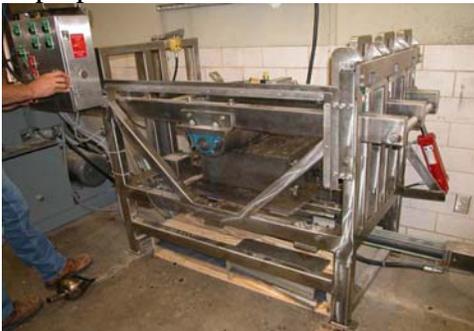
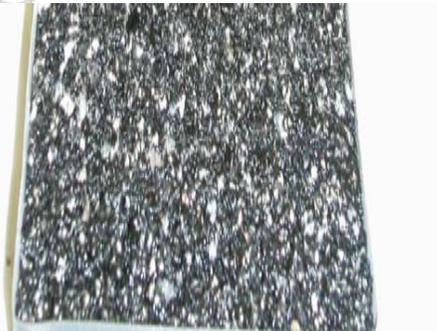
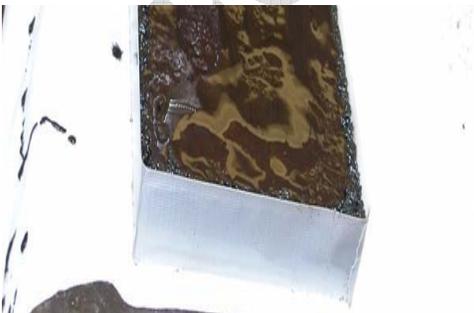
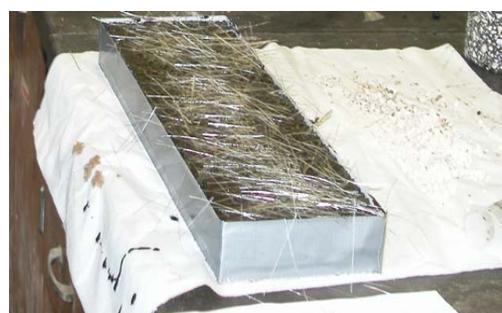
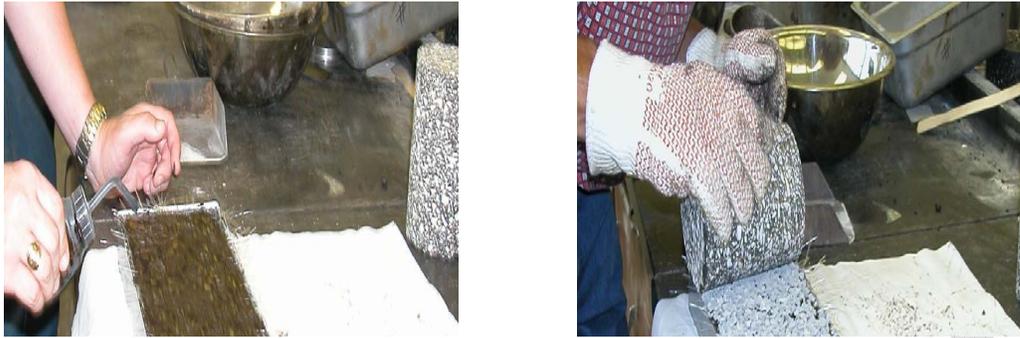
To simulate field conditions, the compacted HMA specimens were maintained within  $7\pm 1$  percent air voids. The bottom layer was compacted as a slab (18 × 6 × 1 inches) using the linear kneading compactor. The bottom slab was allowed to cool to room temperature and left for at least one day. Later, the slab was retrieved from the compaction chamber and encircled with duct tape to avoid tack coat spillage. An appropriate amount of emulsified tack coat was applied onto the top of bottom slab at room temperature. The tack or bond coat was applied using a hand held spray nozzle keeping the slab on top of a balance to ensure the correct amount. Immediately, the emulsion was spread with a paint brush ensuring that no emulsion was lost on the paintbrush.

Previously weighed chopped glass fibers were spread onto the freshly applied tack or bond coat. Cover stone was measured by weighing equal amounts passing sieves No. 4 and sieve No. 8 to cover the slab at a rate of 13 lb/yd<sup>2</sup> (7 kg/m<sup>2</sup>). Cover stone was obtained from the same source as the Superpave mixture. The stone was uniformly spread manually and then rolled with a cylindrical HMA specimen to ensure bonding between the tack and loose stone.

After the emulsion set, some loose stones, which were not adhered to the bond coat, were swept away. In Phase 2 of laboratory specimen preparation, application of cover stone was followed by a final layer of tack coat application to provide better adhesion to the subsequent overlay and show the necessity to have an asphalt layer as per requirements in Superpave.

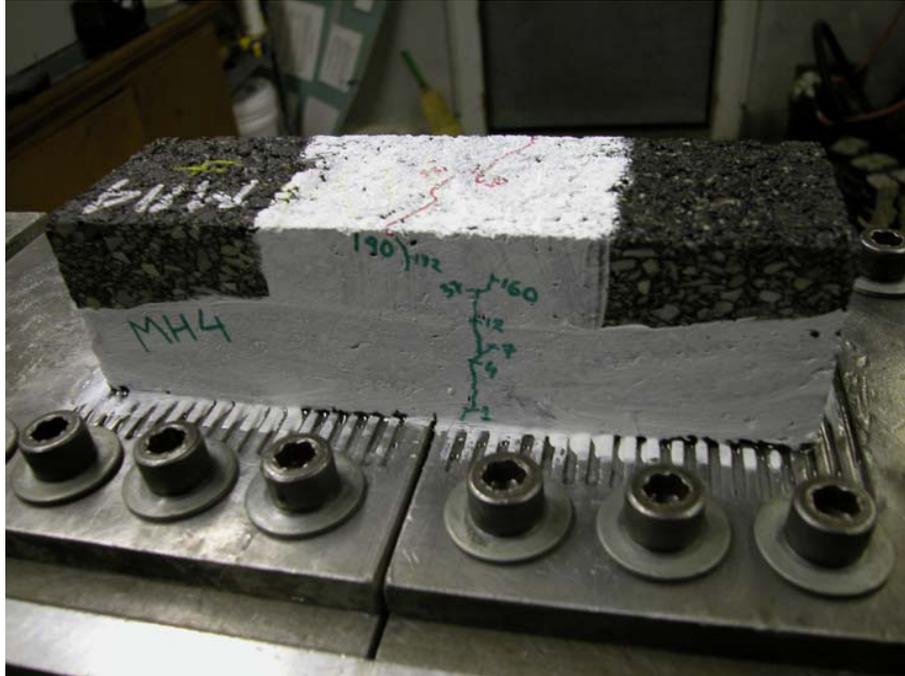
All control specimens were compacted in two layers, and there was only a small amount of tack coat at the interlayer. The control specimens failed quickly for all three test temperatures. They failed vertically. The photo overleaf shows a typical result from control specimens tested at three temperatures. As expected, they survived longer at higher temperatures.
